# Manhole Inspection Summary

Manhole # S15GG2002MH

Insp Date: **7/7/06 11:20 AM**

**Location** Address: **1809 THORNBURY RD**

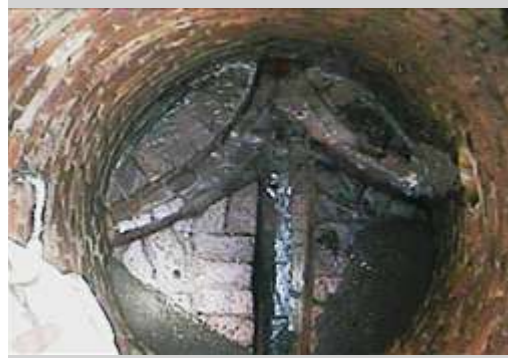
Top View

☐ Parged ☒ **Debris** (not Condition related)

Bench debris.

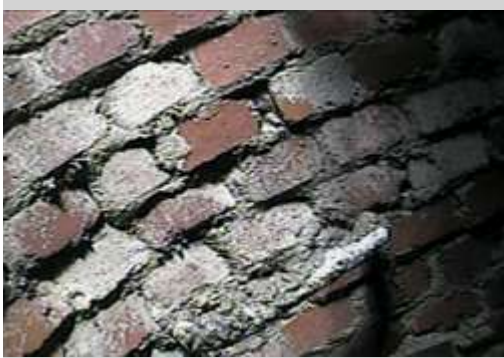
Defect

Condition: ☐ Sound ☐ Cracked ☐ Root Intrusion ☐ Loose Brick ☒ **Deteriorated**

Infiltration: ☐ None ☐ Joint ☐ Cracks ☒ **Mortar** ☐ Roots ☒ **Wall**

Infiltration: ☐ None ☐ Joint ☐ Cracks ☒ **Mortar** ☐ Roots ☐ Wall

Corbel and Barrel deterioration and infiltration.

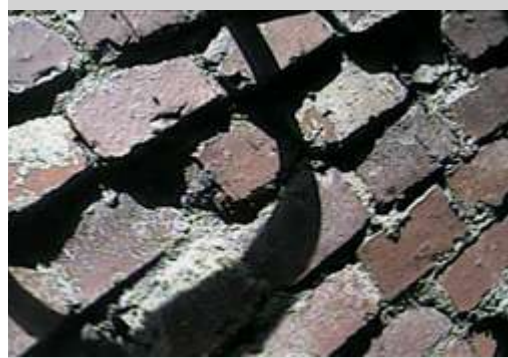
Defect

Condition: ☐ Sound ☐ Cracked ☐ Root Intrusion ☐ Loose Brick ☒ **Deteriorated**

Infiltration: ☐ None ☒ **Joint** ☐ Cracks ☒ **Mortar** ☐ Roots ☐ Wall

Adjustment and Corbel deterioration and infiltration.

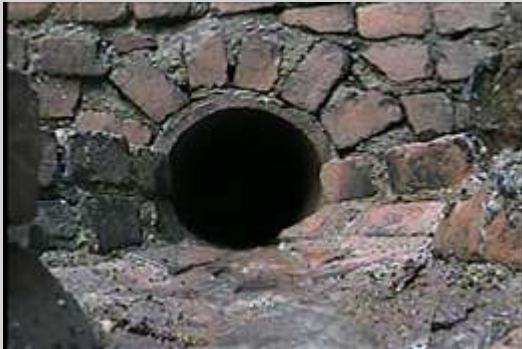
### 8 in. Circular Gravity Sewer Pipe Out @ 12 O'Clock

Barrel deterioration and infiltration. Channel deterioration.

Infiltration: **Evidence** Pipe Seal Cond: **Cracked**

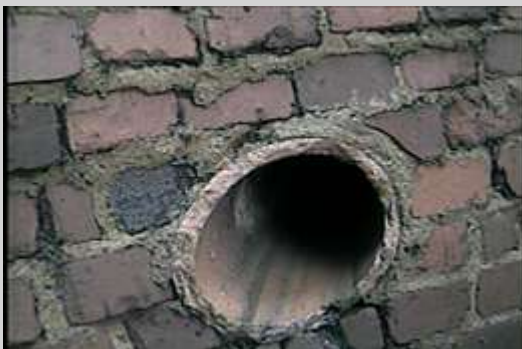
### 6 in. Circular Gravity Sewer Pipe In @ 3 O'Clock

Infiltration: **Evidence** Pipe Seal Cond: **Cracked**

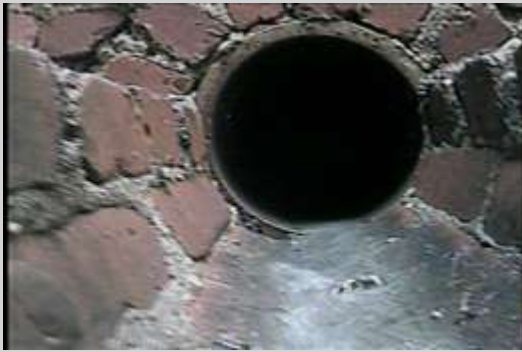
Pipe In @ 6 O'Clock

Infiltration: **Evidence** Pipe Seal Cond: **Unknown**

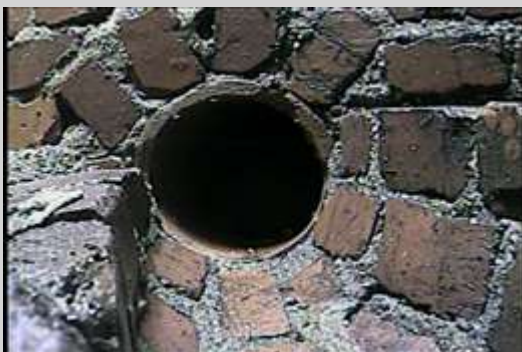
Pipe In @ 8 O'Clock

Infiltration: **Evidence** Pipe Seal Cond: **Unknown**
